Scituate Wastewater Collection System Resilience Feasibility Study – Project Update Meeting

May 31, 2019

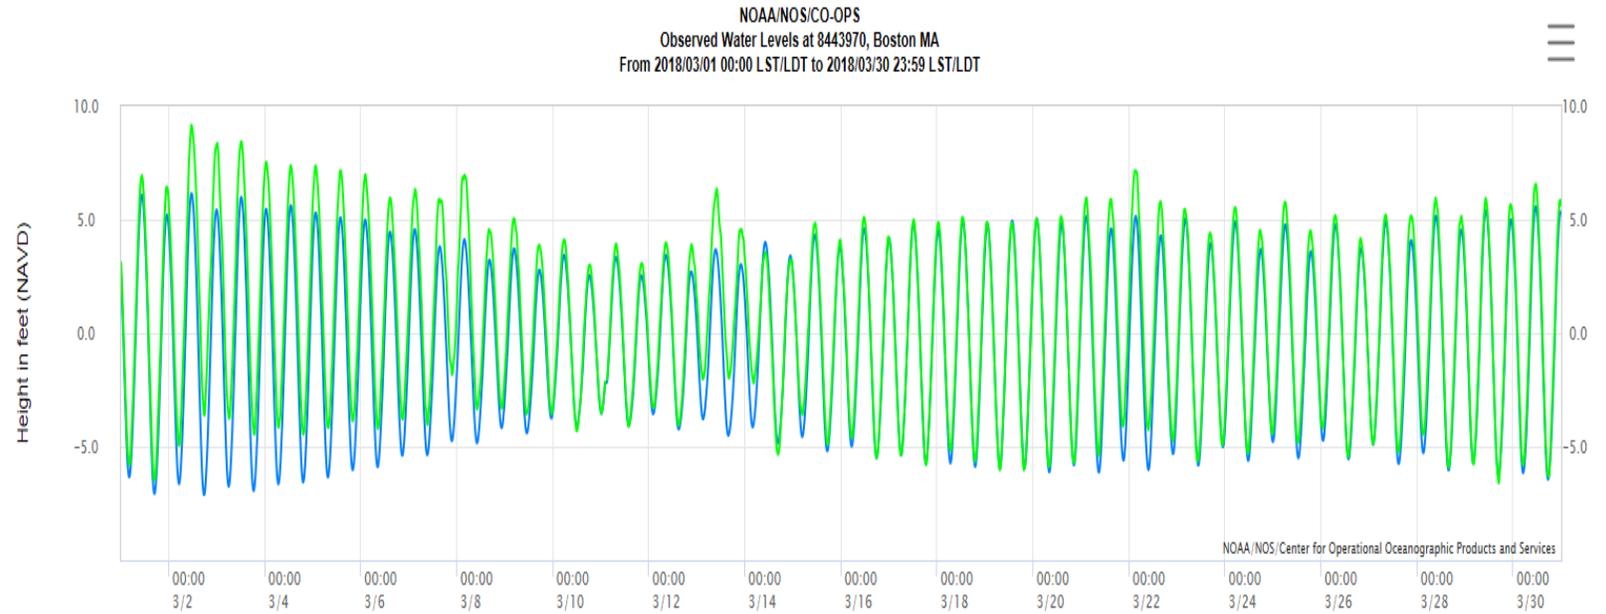
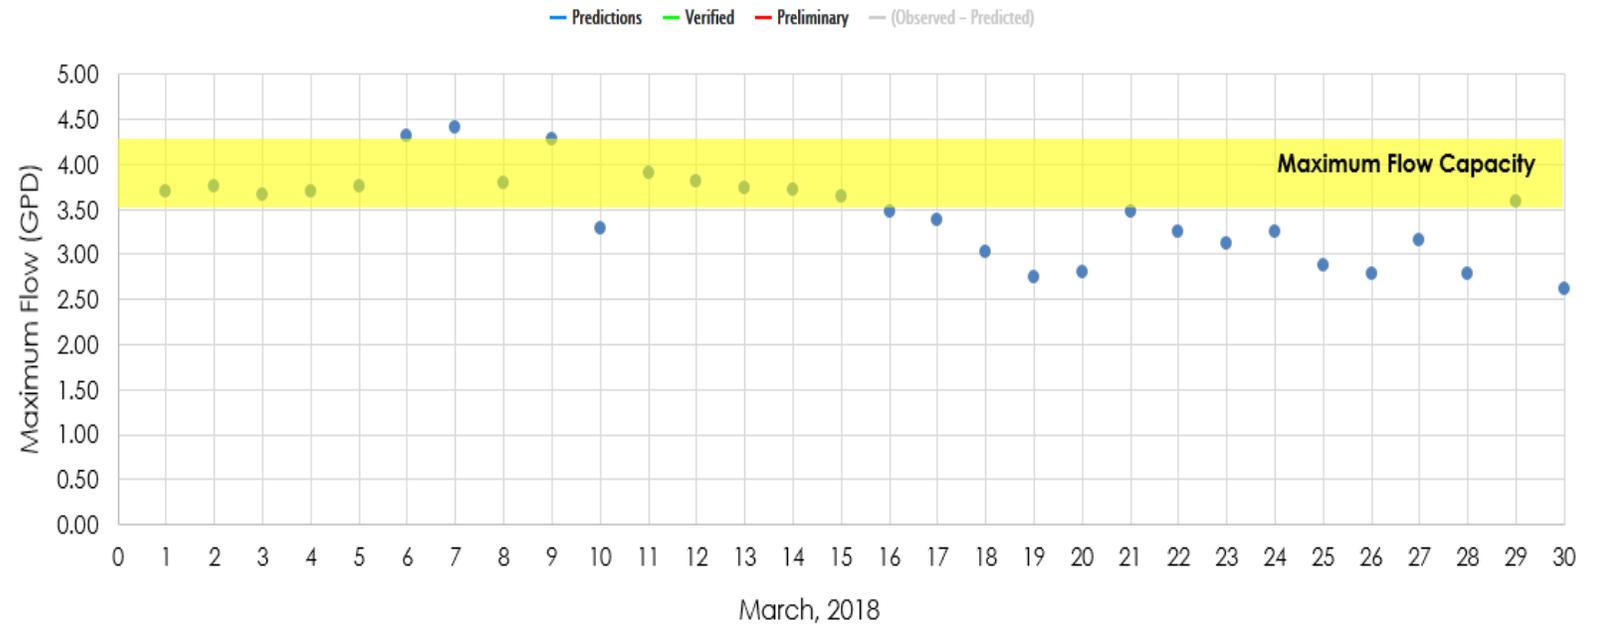
Sand Hills Pump Station March 1-3, 2018

- Collection system and treatment capacity probably is reached during a coastal flood event with stillwater elevation on the order of 9 feet NAVD88 (+/- 50 year recurrence interval in 2019).

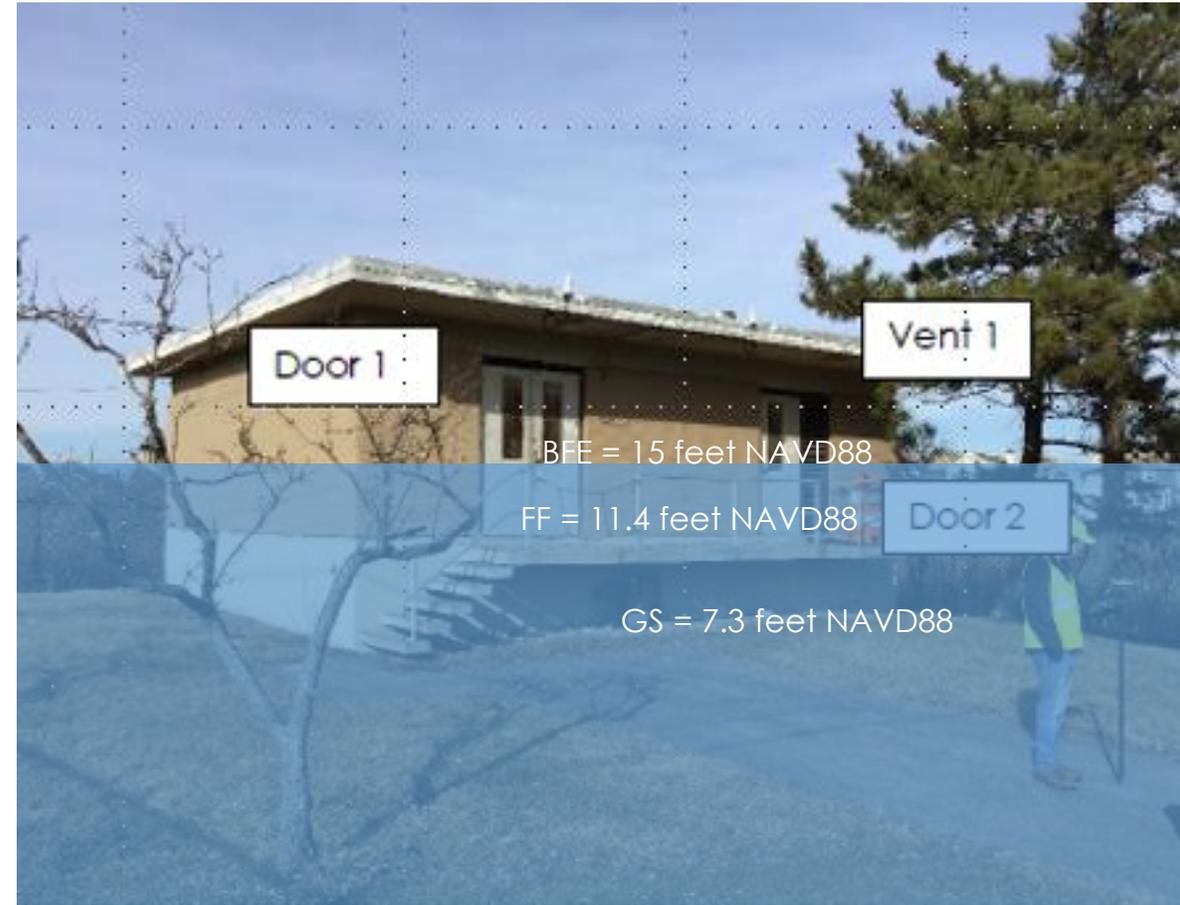
Sands Hill Pump Station

BFE = 15 feet NAVD88

FF = 11.4 feet NAVD88

GS = 7.3 feet NAVD88

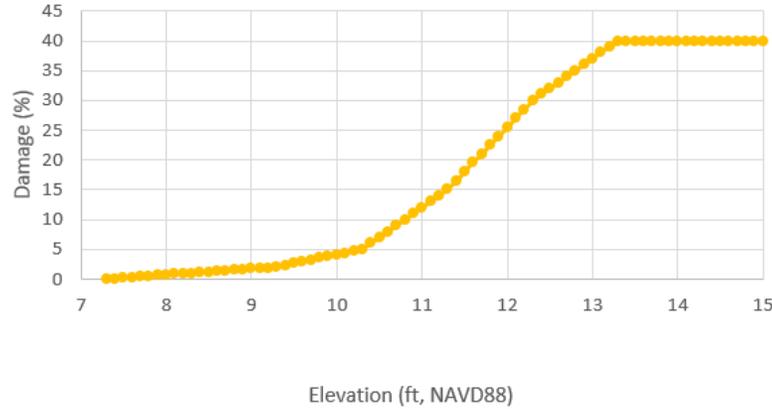
Pump Station Elevation-Damage Curves

Water Entry Points	ID	Description Critical Elevation	Elevation (feet, NGVD29)	Elevation (feet, NAVD88)	Flood Elevation, feet NAVD88											
					7	8	9	10	11	12	13	14	15	16	17	
Windows:		None Observed														
Doors (Personnel and Public):																
Personnel entryway	1	Door Threshold elev.	12.2±	11.4±												
Personnel entryway	2	Door Threshold elev.	12.2±	11.4±												
Vents:																
18" x 88" Vent	Vent 1	Bottom of Vent	12.2±	11.4±												
28" x 40" Vent	Vent 2	Bottom of Vent	16.7±	15.9±												
28" x 40" Vent	Vent 3	Bottom of Vent	16.7±	15.9±												
28" x 88" Vent	Vent 4	Bottom of Vent	12.2±	11.4±												
28" x 88" Vent	Vent 5	Bottom of Vent	12.2±	11.4±												
8" x 8" Vent	Vent 6	Bottom of Vent	12.4±	11.6±												
8" x 8" Vent	Vent 7	Bottom of Vent	14.0±	13.2±												
Other																
Outside Electric Meter Panel		Lowest Elevation	13.9±	13.1±

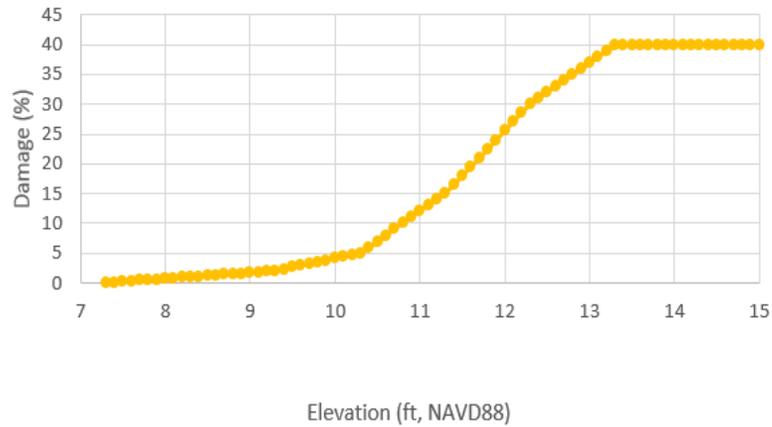
Treatment Plant Elevation-Damage Curves

Treatment Plant SSCs	Flood Elevation, feet NAVD88										
	7	8	9	10	11	12	13	14	15	16	17
Sludge Dewatering Building	Green	Green	Green	Green	Green	Red	Red	Red	Red	Red	Red
Operations Building	Green	Green	Green	Green	Green	Red	Red	Red	Red	Red	Red
Septage Building	Green	Green	Green	Green	Green	Green	Green	Green	Green	Red	Red
Blower Building	Green	Green	Green	Green	Green	Green	Green	Green	Green	Red	Red
Generator Building	Green	Green	Green	Green	Green	Green	Red	Red	Red	Red	Red
Filter Building	Green	Green	Green	Green	Green	Green	Red	Red	Red	Red	Red
Methane Building	Green	Green	Green	Green	Green	Green	Green	Green	Green	Red	Red
Aeration Tanks	Green	Green	Green	Green	Green	Green	Green	Green	Green	Red	Red
Aerobic Digesters	Green	Green	Green	Green	Green	Green	Green	Green	Green	Red	Red
Soda Ash Silo	Green	Green	Green	Green	Green	Green	Green	Green	Green	Green	Green
Settling Tanks	Green	Green	Green	Green	Green	Green	Green	Green	Red	Red	Red

Notes:
 Green indicates No Impact.
 Red indicates Some to Significant Impact.
 Bold SSC indicates that structure is critical to complete treatment plant failure.

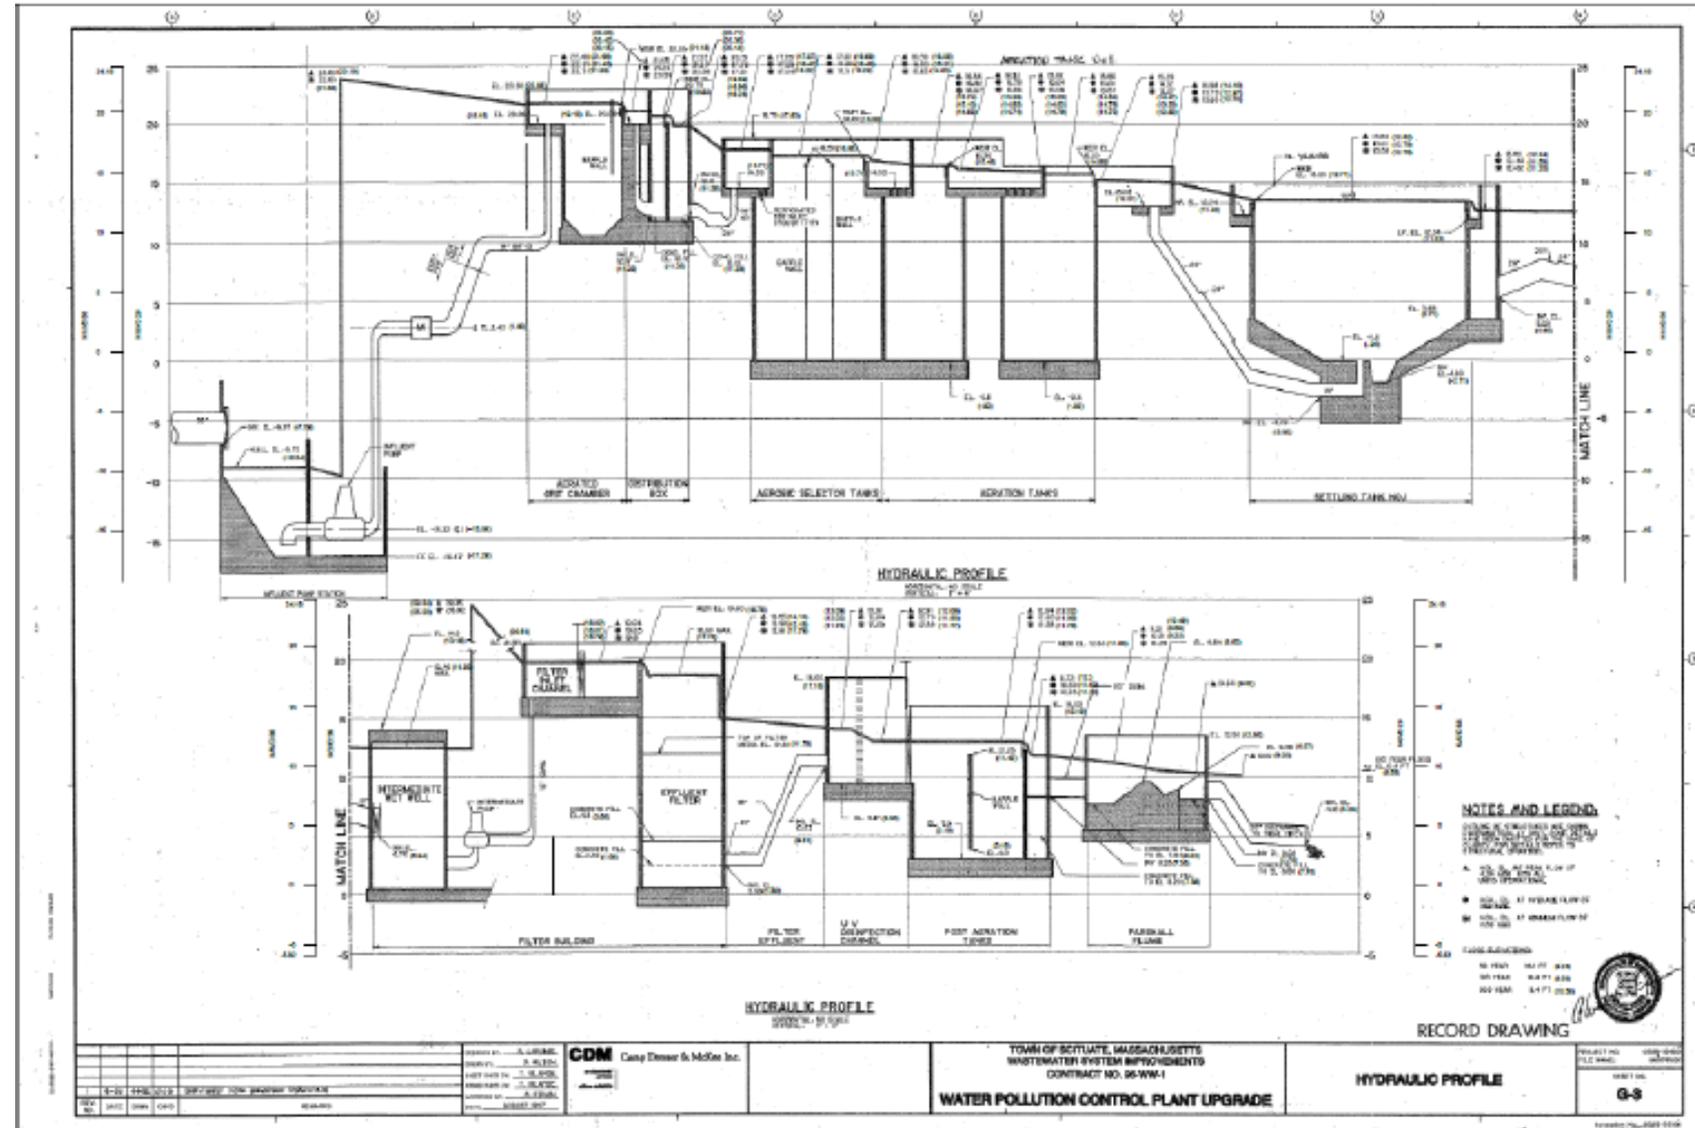
Figure 3-10 Hydraulic Profile

Allow for peak hourly flows to be passed through the plant with the receiving water at the 100-year recurrence interval flood elevation (including considerations of climate change):

- Design: El. 9.5 NAVD88

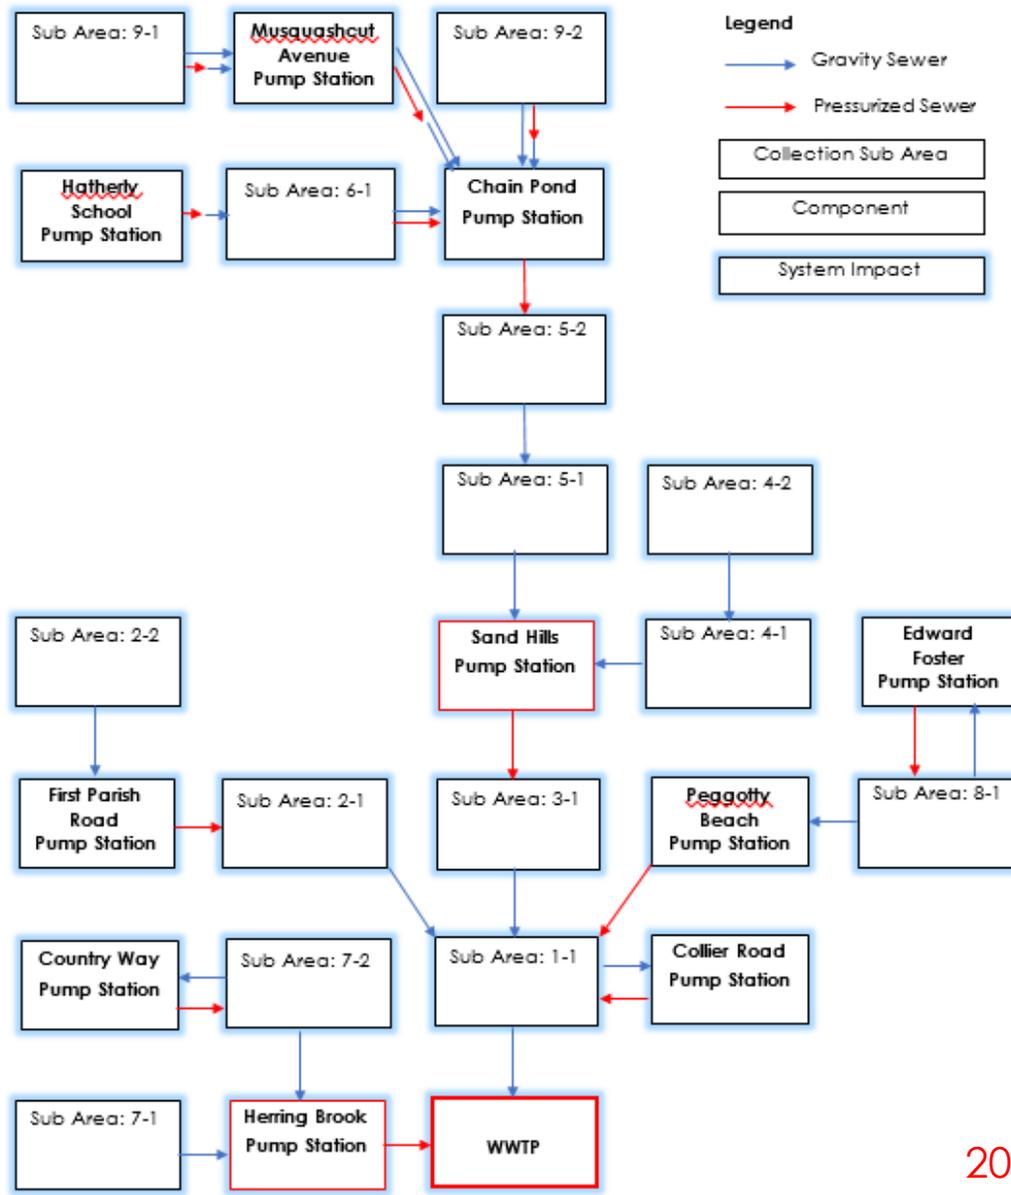
Figure 5: Schematic Chart of Soituate Wastewater Collections System: 50-year recurrence interval (2019)

2019: +/- 50-yr Rec Int.
